**September 28, 2020**

## **Asbestos Inspection Report**

7875 Wood Haven Road  
Roanoke, Virginia

Western Virginia Regional Industrial Facility Authority  
PO Box 2569  
Roanoke, VA 24010

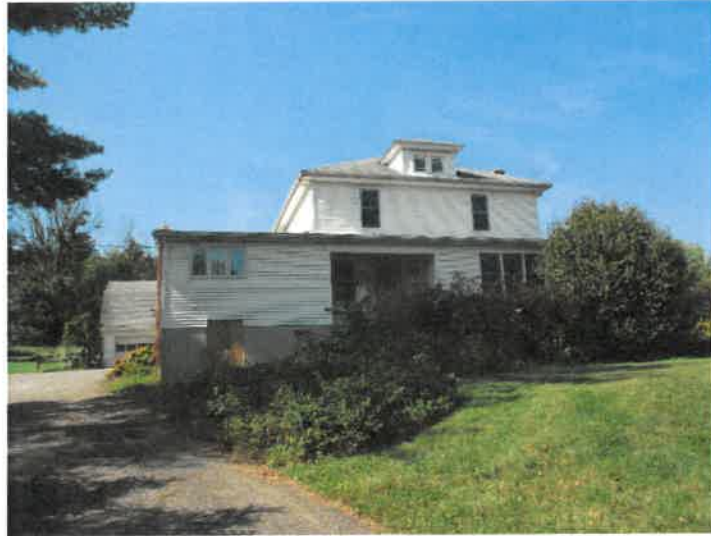
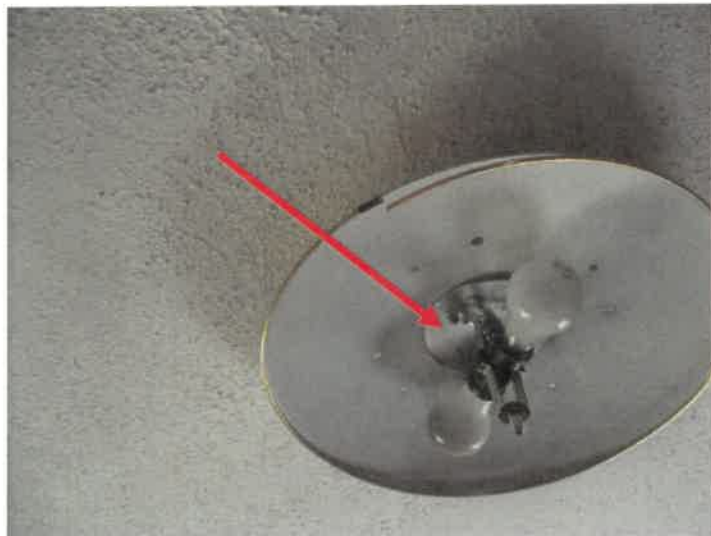
- Light Shield – Living Room Light Fixture

20053289 -018	SR 9.1	Sheetrock	ND	-
20053289 -019	SR 9.2	Sheetrock	ND	-
20053289 -020	SR 9.3	Sheetrock	ND	-
20053289 -021	JC 10.1	Joint Compound	ND	-
20053289 -022	JC 10.2	Joint Compound	ND	-
20053289 -023	JC 10.3	Joint Compound	ND	-
20053289 -024	LS 11.1	Light Sheild Insulation	■	45%
20053289 -025	LS 11.2	Light Sheild Insulation	NA	PS
20053289 -026	LN 12.1	Linoleum- Downstairs Bathroom	ND	-
20053289 -027	LN 12.2	Linoleum- Downstairs Bathroom	ND	-
20053289 -028	LN 13.1	Linoleum- Master Bathroom	ND	-
20053289 -029	LN 13.2	Linoleum- Master Bathroom	ND	-
20053289 -030	BI 14.1	Blown Insulation	ND	-
20053289 -031	BI 14.2	Blown Insulation	ND	-
20053289 -032	BI 14.3	Blown Insulation	ND	-

**The Light Shield on the living room light fixture was found to be Asbestos Containing by the laboratory.**

These NON-Friable asbestos containing materials should be removed prior to demolition activities at this location. Removal should be performed by licensed, contract personnel using approved methods.
