DETENTION BASIN INSPECTION REPORT

| Facility Name: | Wood Haven Technology Park Detention Basin 1 | Tax Parcel ID: | 026.17-01-01.00-0000 |

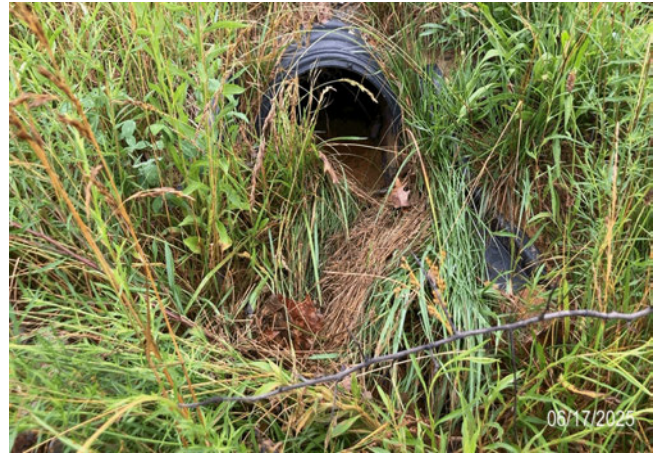
| 1. Is the storm drain filled more than 25% with debris, sediment, or trash? | Yes | Remove accumulated sediment from within and below the northwest inflow pipe. |

Remove accumulated sediment from within and below the northwest inflow pipe.

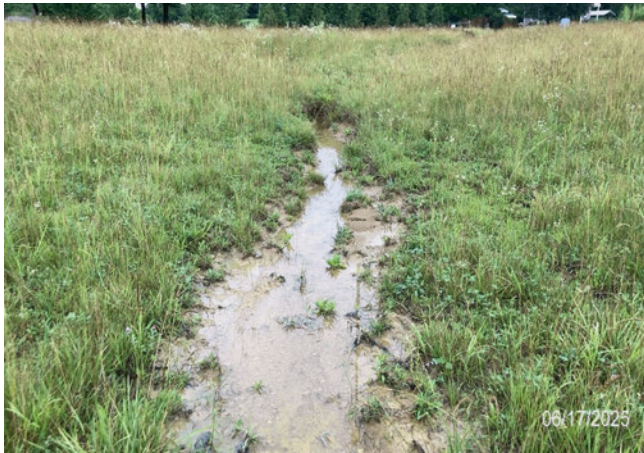
| Inspection Questions | Answer | Corrective Action/Notes |
|---|---|--|
| 3. Is there evidence of erosion? | Yes | Repair and stabilize eroded areas within the southeast inflow channel. |

| 3. Are there bare areas which need seeding or sodding? | Yes | Apply seed and straw to all bare areas once repairs are complete. |

Repair and stabilize eroded areas within the southeast inflow channel. Apply seed and straw mulch to all bare areas once repairs are complete.

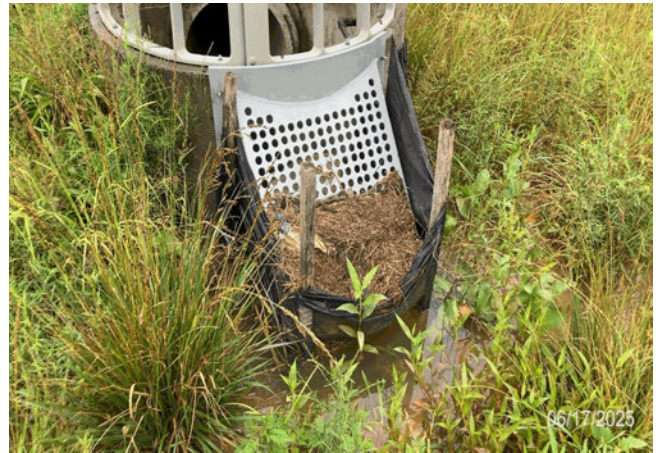
| Inspection Questions | Answer | Corrective Action/Notes |
|---|---|--|
| 1. Is the structure clean of debris and sediment, free of damage, and in working order? | No | Remove silt fence from around the debris rack. |

Remove silt fence from around the debris rack.
